Righting the Wrongs

Interesting repairs to a Verge Watch by Ian W Wright

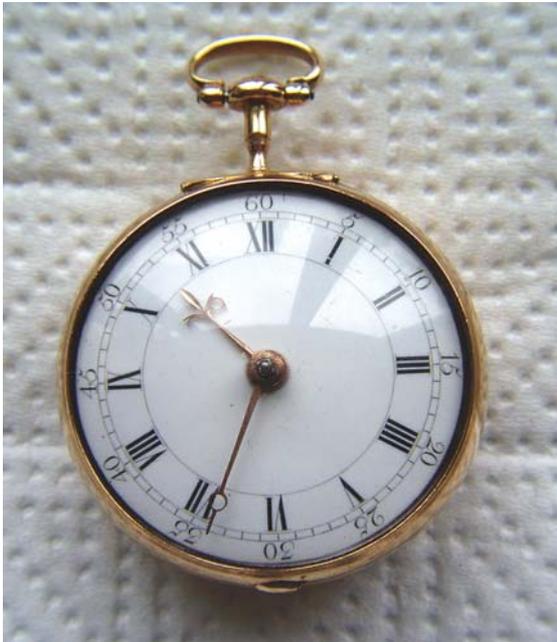
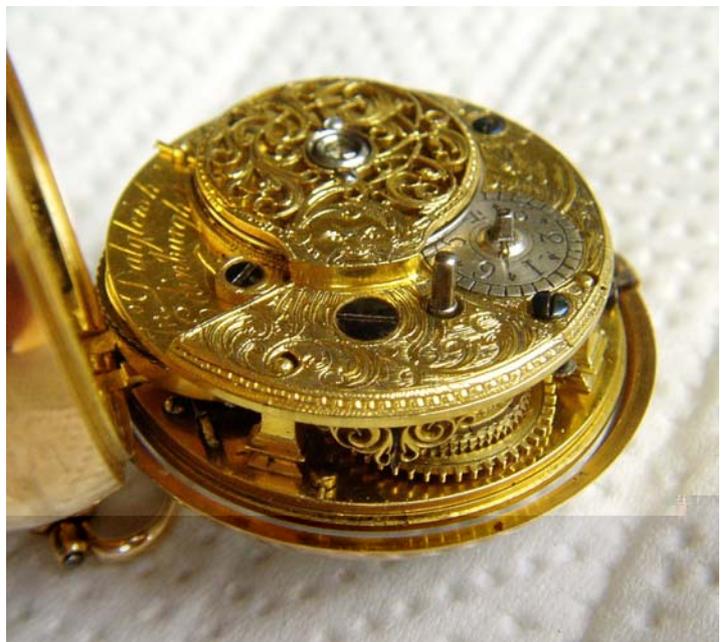
Fig 1.

The watch itself is a nice verge pocket watch in a gold pair case which is London hallmarked for 1761. Like many such watches still in existence, it has obviously enjoyed a long and useful life as a timekeeper, indicated by the wear marks around the inner case and the fact that the pendant has, at some time in the past, been replaced. (Figs 1 & 2)

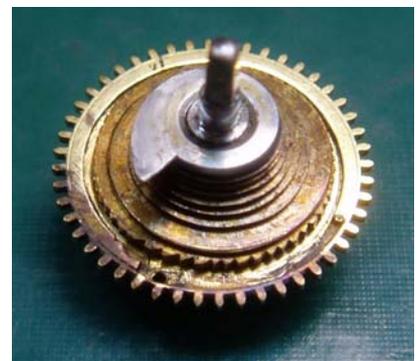
Considering this latter problem first, the initial state of the fusee can be seen in fig. 3 where you can see that the click is completely missing and the circular brass spring controlling it has the acting end broken off. Not only this, but the

ratchet teeth on the periphery of the fusee have been crudely and unevenly filed in an attempt to deepen them and persuade an obviously ailing ratchet system to work. In actual fact, of course, it is this filing of the teeth which undoubtedly led to the demise of the click which was being asked to work at an awkward angle and to accept loadings which it wasn't designed for.

Fig 3. Damaged fusee from top showing missing click, broken spring and badly filed teeth.

The old brass circular click spring was carefully removed from the great wheel - it was pinned into place by three small brass pins, the wheel recess was cleaned out and the distortion where the click had broken out was tapped level. The spring was now measured and a new ring of hard brass was turned to form the basis of the new spring. This allowed an assessment to be made of the correct outside diam-

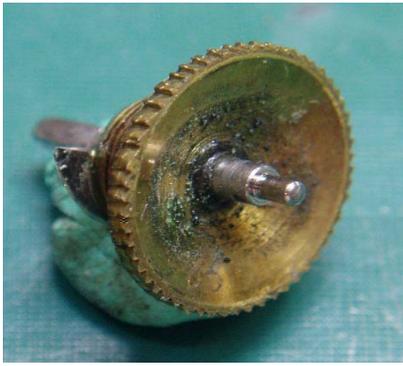
The teeth filed into the fusee, Fig 4, presented something of a dilemma - should the fusee be completely replaced with a new one, or should a restoration be carried out which would preserve as much of the original part as possible? In the event it was decided that an attempt should be made to preserve the original part.

Fig 4. Underside of damaged fusee cone showing roughly filed teeth

Next, the height of the fusee cone was measured and, in the lathe, this was reduced by the correct amount to accept a new ratchet. This step is critical as final freedom of the winding depends upon the finished overall length being exactly the same as the original. In this particular case, the existing filed teeth still encroached onto the actual cone and chain track but it

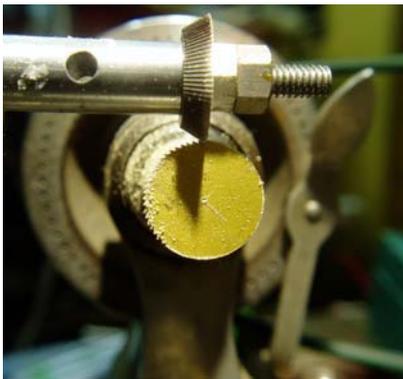
Fig 5. Cutting the new ratchet wheel

was felt that, as there was no mechanical interference with the operation of the chain, the cosmetic imperfections could be tolerated. The original fusee body is made of cast brass and so, to maintain as much similarity as possible, a disk was cut from a cast brass sheet and turned to the overall size of the new ratchet. It was possible to determine from the filed teeth that the original ratchet had 60 teeth - a very convenient number, and so the blank, mounted on a wax chuck, could be easily cut in the normal watch lathe using the index holes on the pulley. (Fig 5.)

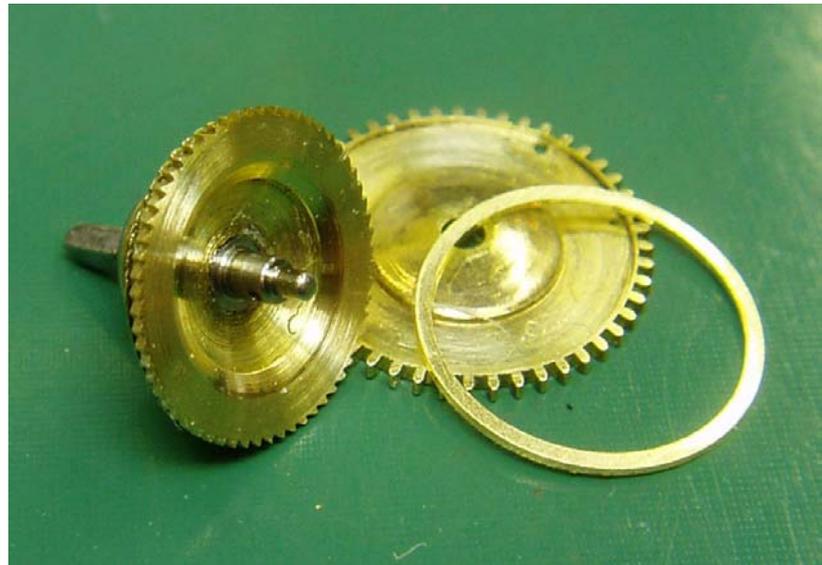
Fig 6. Ratchet fitted to fusee and new spring blank.

arbor and was temporarily secured to the fusee with a couple of dabs of 'superglue'. Now, carefully considering distances and angles, four holes were drilled through the ratchet into the fusee for securing pins. As the centre of the ratchet would be turned away to clear the central boss of the great wheel and yet the pins must not protrude into any of the chain track, these holes had to be at an angle matching the fusee cone and within a very narrow band. Of course, as the pins are at an angle, they form the only retention necessary with, perhaps, the added security that the ratchet is always trapped between the fusee and the great wheel. With the holes drilled, four slightly tapered brass pins were hammered into place and the ends turned level and polished to merge in with the ratchet. Now the centre of the new ratchet could be turned away until it was clear of the great wheel boss and the new blended smoothly into the old.

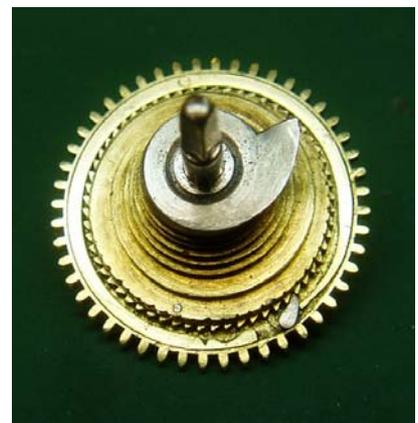
Fig 7. The repaired fusee

So, work on the fusee was now complete and the parts could be reassembled and tested. A satisfying result, but

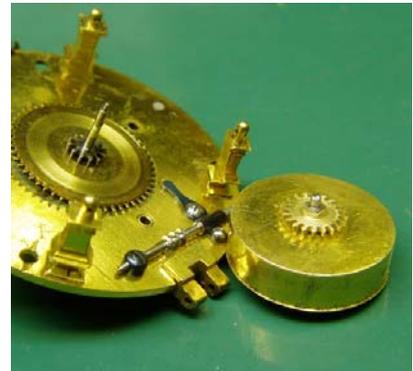
Fig 9. The new set-up wheel fitted to the barrel arbor.

Cutting of the wheel is relatively straightforward and so I shall not describe it here but I am happy to report that the watch is now once again fully functional and keeping time to within a few seconds a day.
